Report No. UT-02.17

***PAVEMENT AND
SUBGRADE DISTRESS –
REMEDIAL STRATEGIES
FOR CONSTRUCTION AND
MAINTENANCE (I-15
Mileposts 200-217)***

**By: Kyle M. Rollins, Ph.D
Ryan Christie**

**Utah Department of Transportation
Research Division**

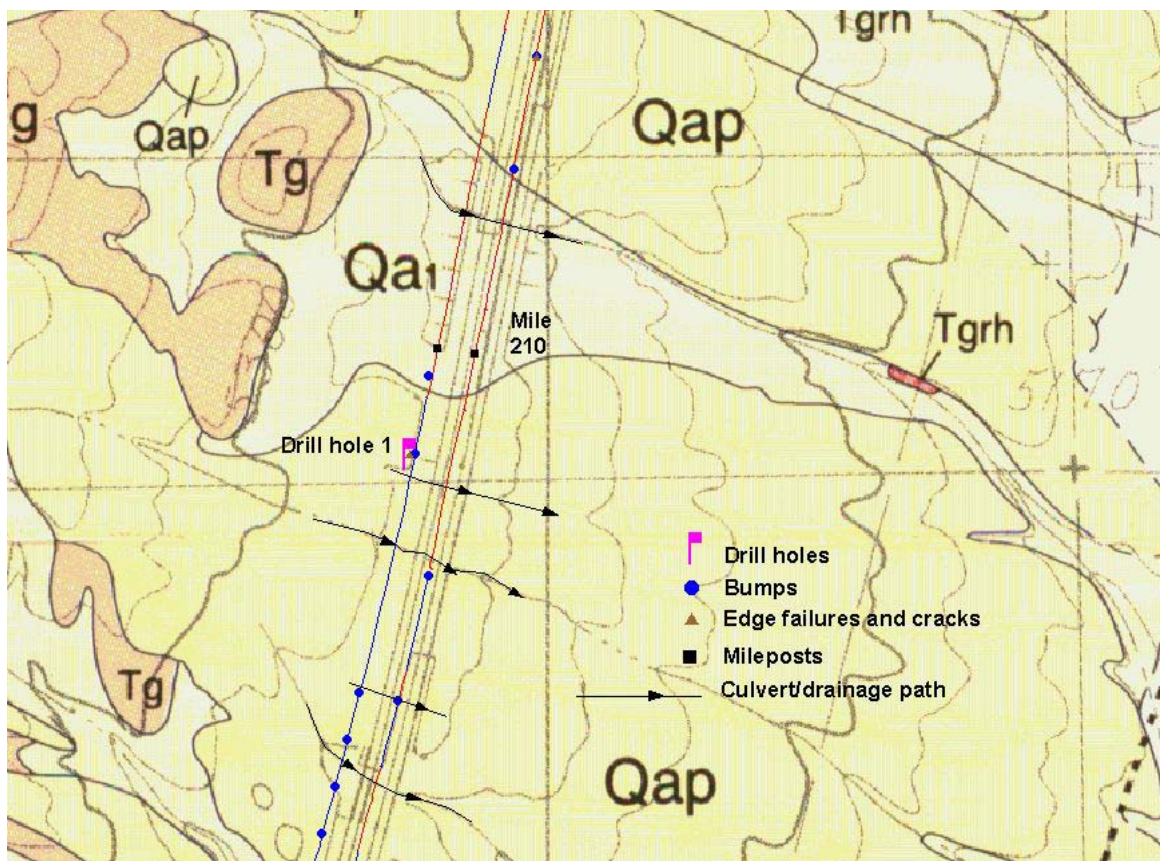
Drill Hole 1 is located in the west cut section on the west side of southbound lane, just a few hundred feet south of milepost 210 as shown in Figure 27. Drill Hole 1 was drilled to a depth of 4.5 feet through alluvial fan deposits and into weathered shale/mudstone. The soil profile for the borehole log is shown in Figure 28. Drill Hole 1 is located within geologic unit Qap. Drill Hole 1 does have mildly expansive soils at 3.5 feet deep. Distress features possibly relate to a collapsible/expansive soils, cut/fill transition zones, and a lack of proper drainage. Figure 29 is a picture of a large longitudinal crack next to Drill Hole 1. This crack is likely related to the moderately expansive clays located in the area. One bump near Drill Hole 1 is located within 100 feet of a cut/fill transition zone. Another bump near Drill Hole 1 is located within 100 feet of a cut/fill transition zone and a culvert. One other bump near Drill Hole 1 is located within 100 feet of a culvert. The final six distress features (6 bumps and 1 edge failure) are possibly related to the subsurface soils under the highway.

Figure 27: Drill Hole 1 and the distress features nearby, I-15, Juab County, UT. Cuts are in blue and fills are in red.

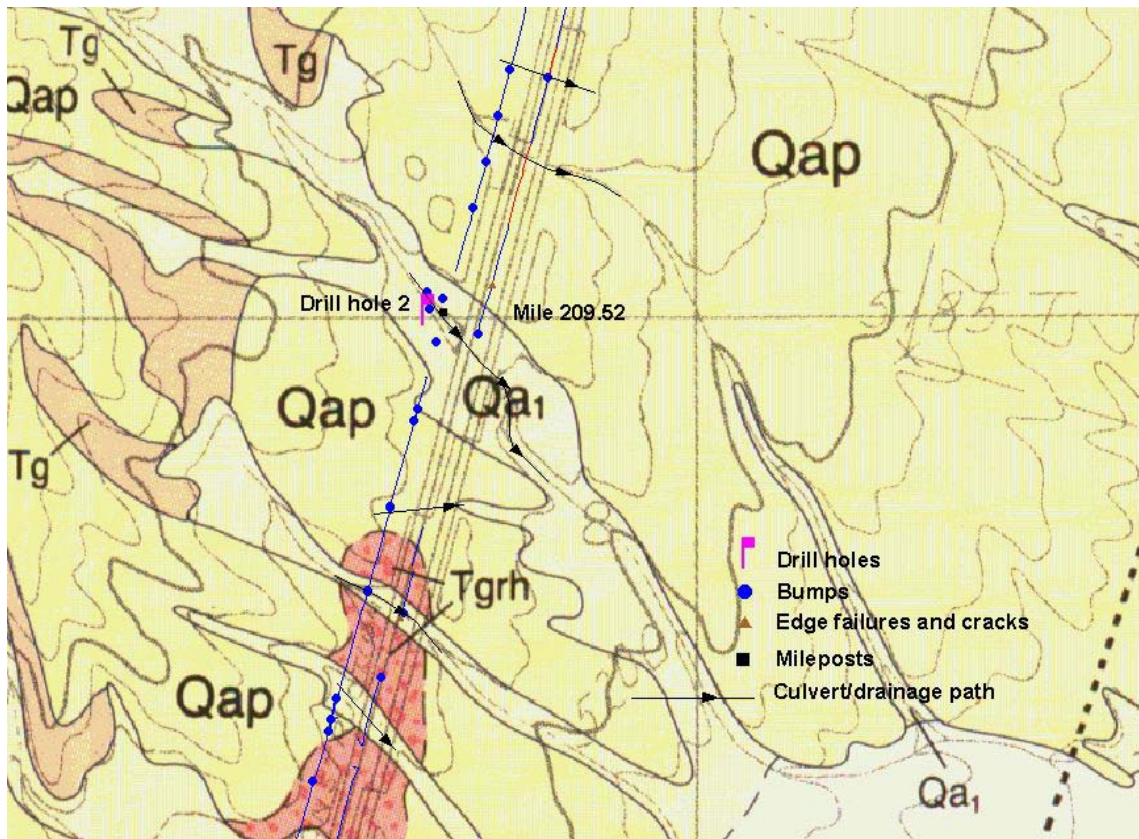
Drill Hole 2 is located on a shallow eastward dipping slope, west of the southbound lanes of I-15 (see Figure 32). Drill Hole 2 is about 0.48 miles south of milepost 210. It was drilled to a depth of 19.5 feet through clay and sand beds underlain by sand and gravel beds. Collapsible soils were identified from the surface to at least a depth of 10 feet. The potential for collapse appears to be substantially lower in the soils below a depth of 18.5 feet.

Figure 32: Drill Hole 2 and the distress features nearby, I-15, Juab County, UT. Cuts are in blue and fills are in red.

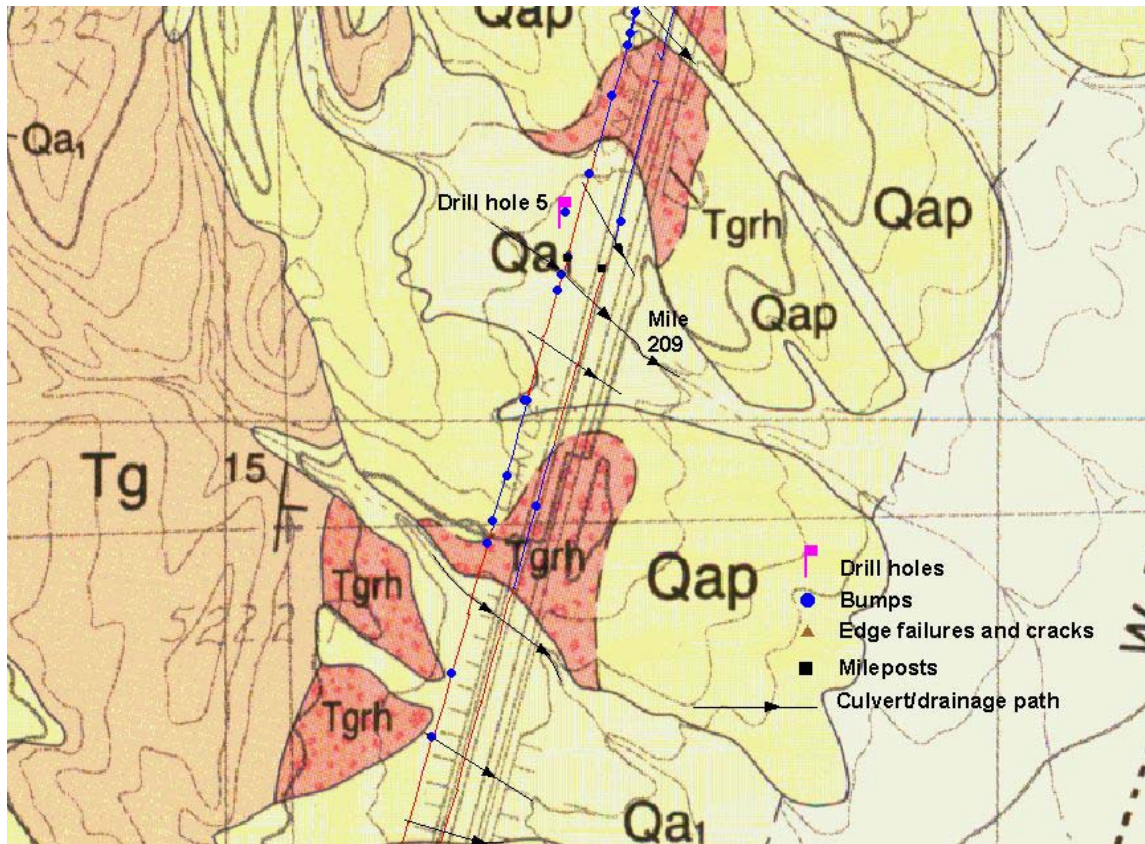
Drill Hole 5 is located south of a large cut, on a shallow eastward dipping slope, west of the southbound lanes of I-15 (see Figure 33). Drill Hole 5 is a few hundred feet north of milepost 209. This hole was drilled to a depth of 16.5 feet through clay and sand beds, sand and gravel

Figure 33: Drill Hole 5 and the distress features nearby, I-15, Juab County, UT. Cuts are in blue and fills are in red.

There are 33 different distress features found on the maps of the areas around Drill Holes 2 and 5 (Figures 30 and 31). Of these 33 features, 31 are bumps and 2 are edge failures. Nine bumps are found within 100 feet of a culvert/drainage path. Four bumps are found within 100 feet of a cut/fill transition zone. One edge failure and 2 bumps are found within 100 feet of both a culvert/drainage path and a cut/fill transition zone. One edge failure and 16 bumps are possibly related to just the subsurface geology. The majority of the soil samples from both holes were found to be collapsible in nature with a few expansive materials at depth.

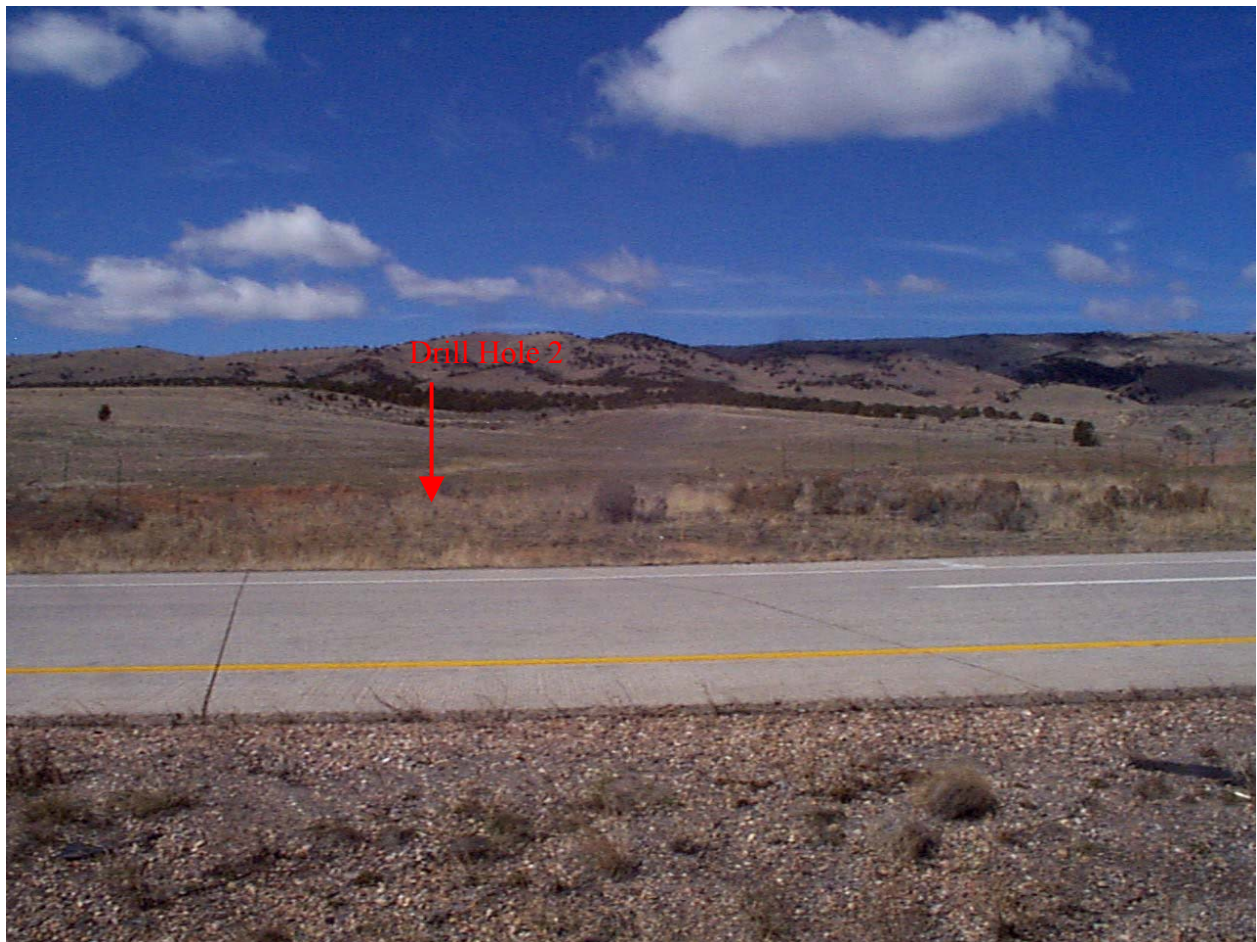
Figures 36 through 41 are pictures of areas and distress features taken around Drill Hole 2. They show where Drill Hole 2 is located, troughs and bumps around Drill Hole 2, and a plant-filled drainage ditch leading to a culvert that passes from west to east under I-15. Troughs and bumps are near the culvert and might be related to soils collapsing around the culvert when water permeates into the soil. Figures 42 through 45 are pictures of areas and distress features around Drill Hole 5. They show where Drill Hole 5 is located, bumps along the highway, and a drainage ditch leading to a culvert that passes from west to east under I-15. Bumps are also near this culvert and might be related to soils collapsing around the culvert when water permeates into the soil (Fig. 45).

Figure 36: Looking west at the area around Drill Hole 2 near the southbound lanes of I-15. Drill Hole 2 was drilled in the center of the photo through the stream alluvial deposits creating the flat section between the alluvial fans.

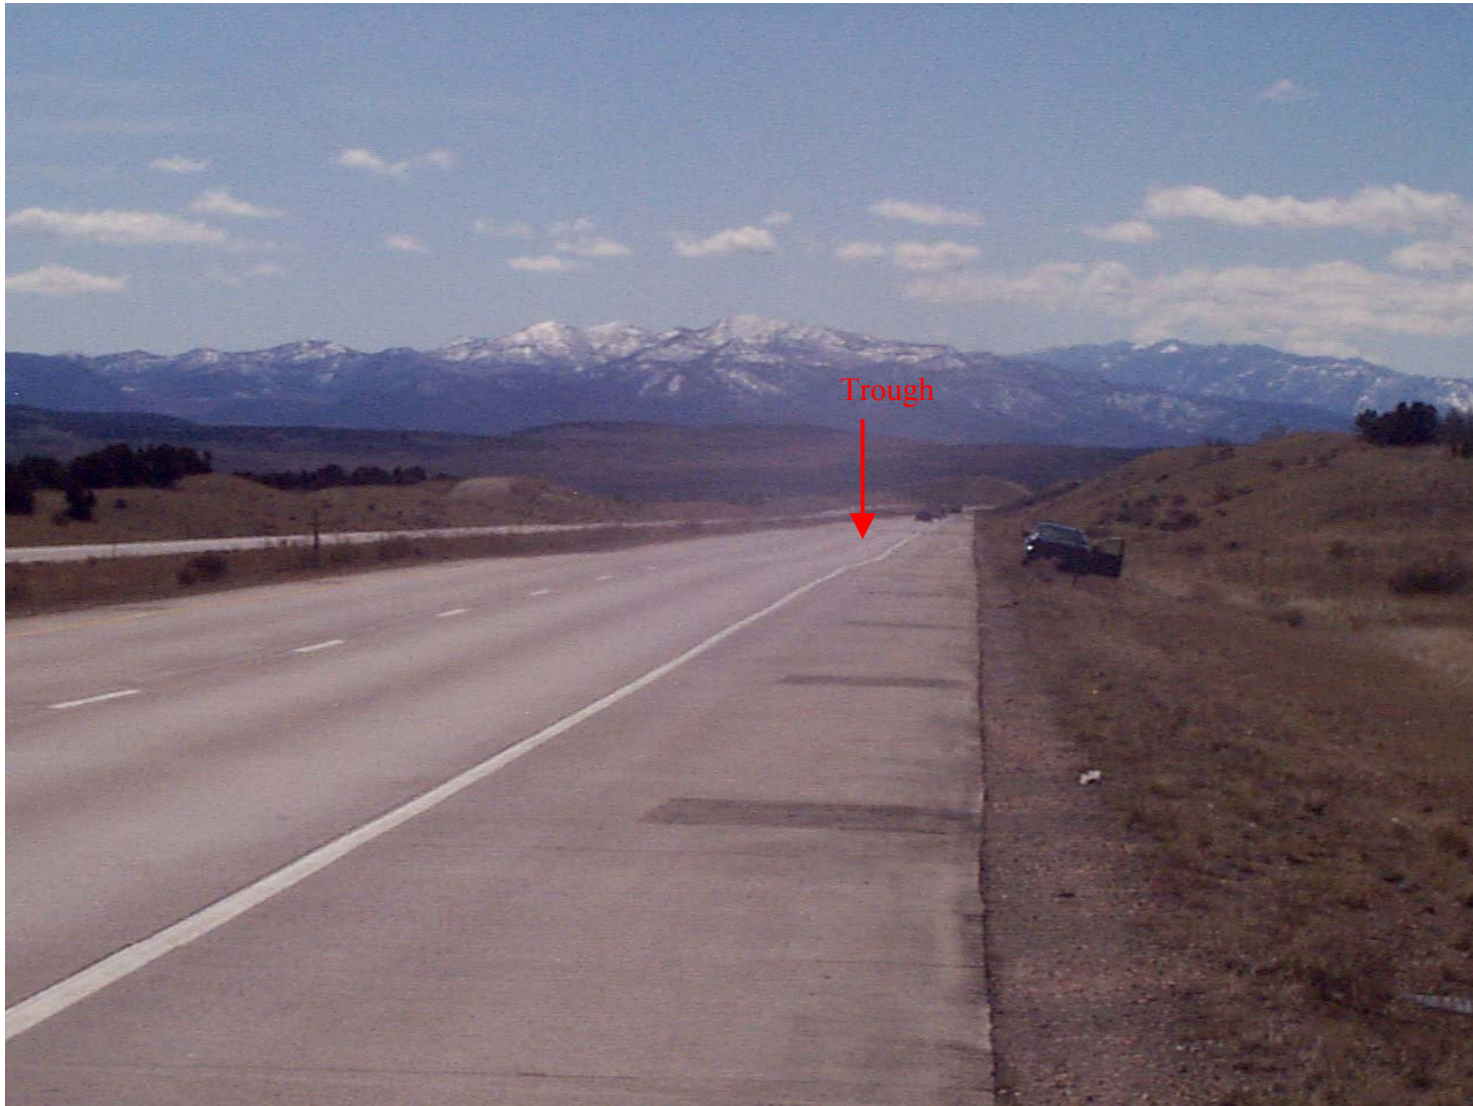
Figure 37: Trough causing loss of ride quality. The trough is near a drainage and near Drill Hole 2, Juab County, UT.

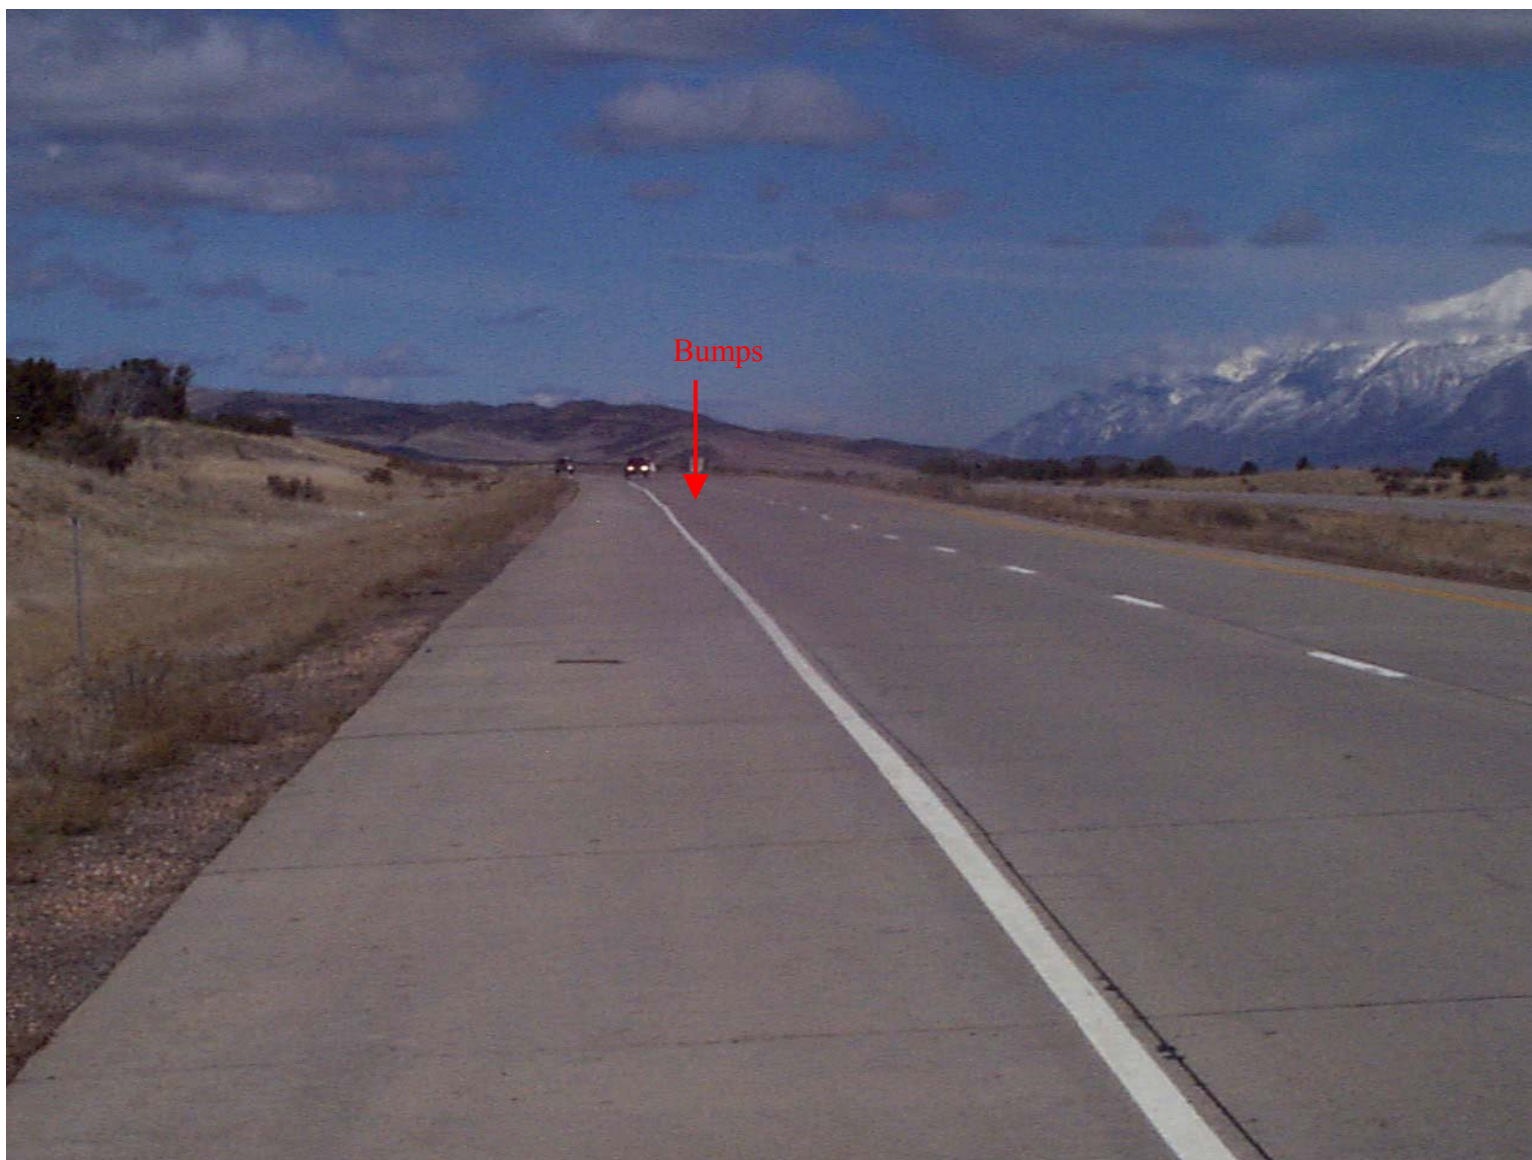
Figure 38: Looking north from Drill Hole 2 along the southbound lanes of I-15. Several bumps can be seen in the middle of the picture.

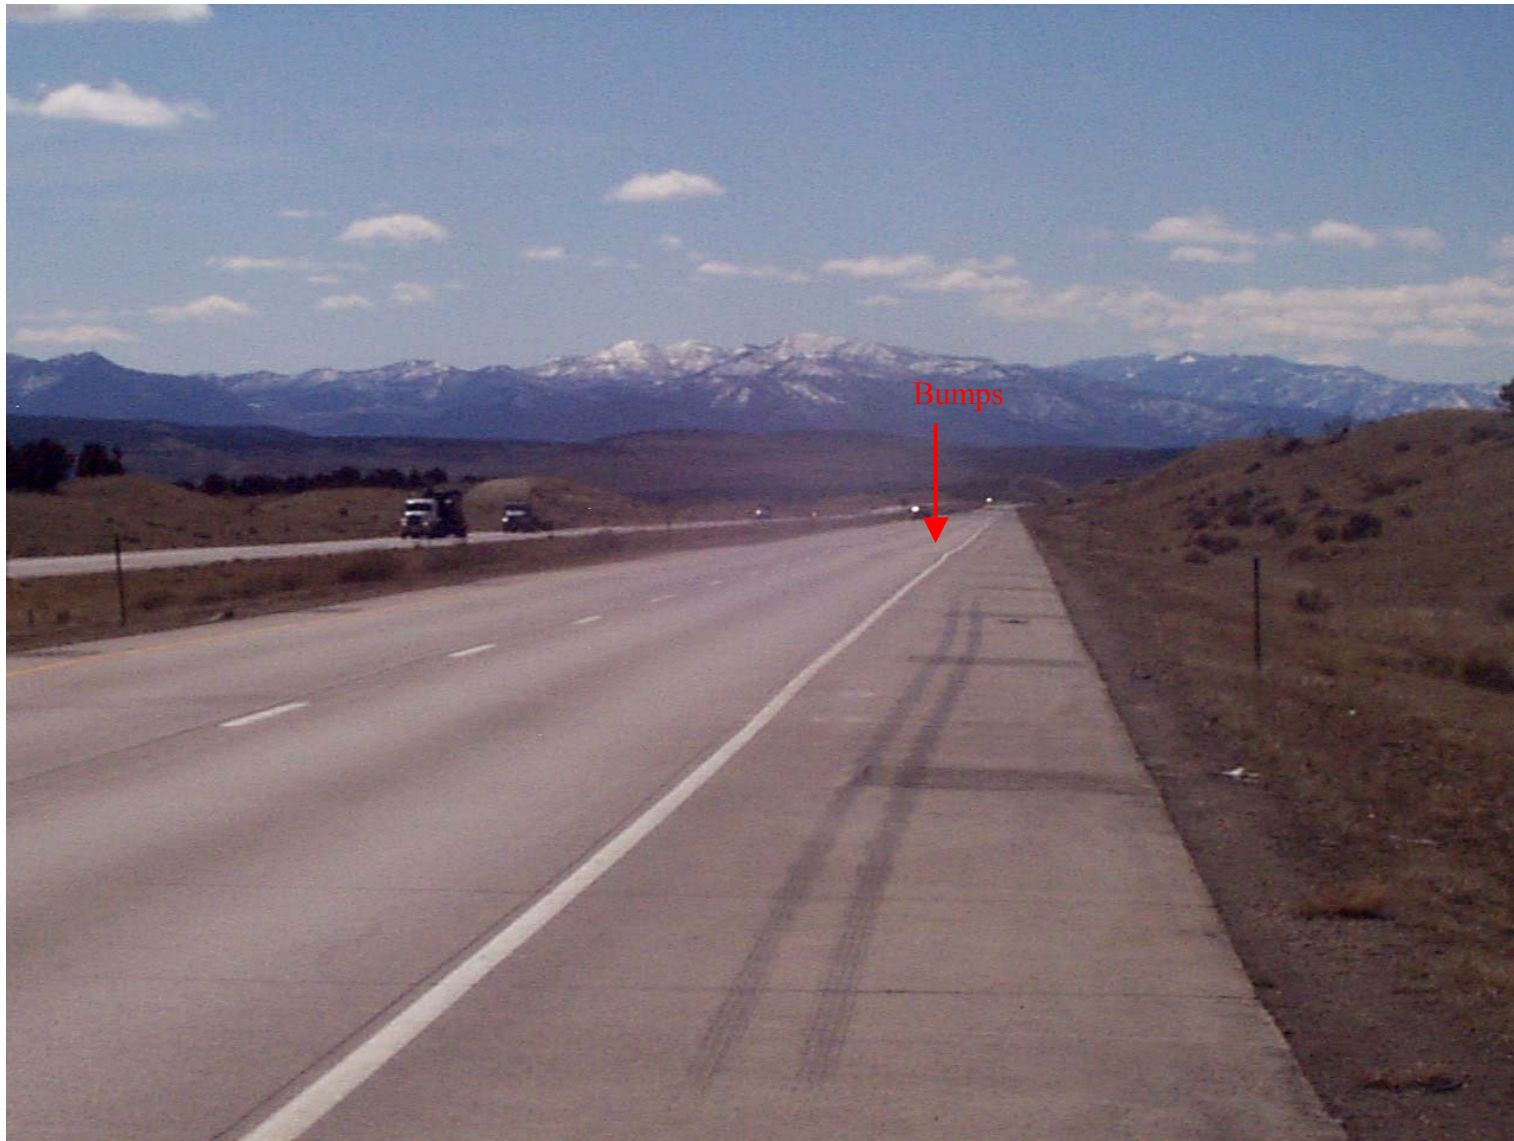
Figure 39: Looking south from Drill Hole 2 along the southbound lanes of I-15. A trough and several bumps can be seen in the middle of the picture.

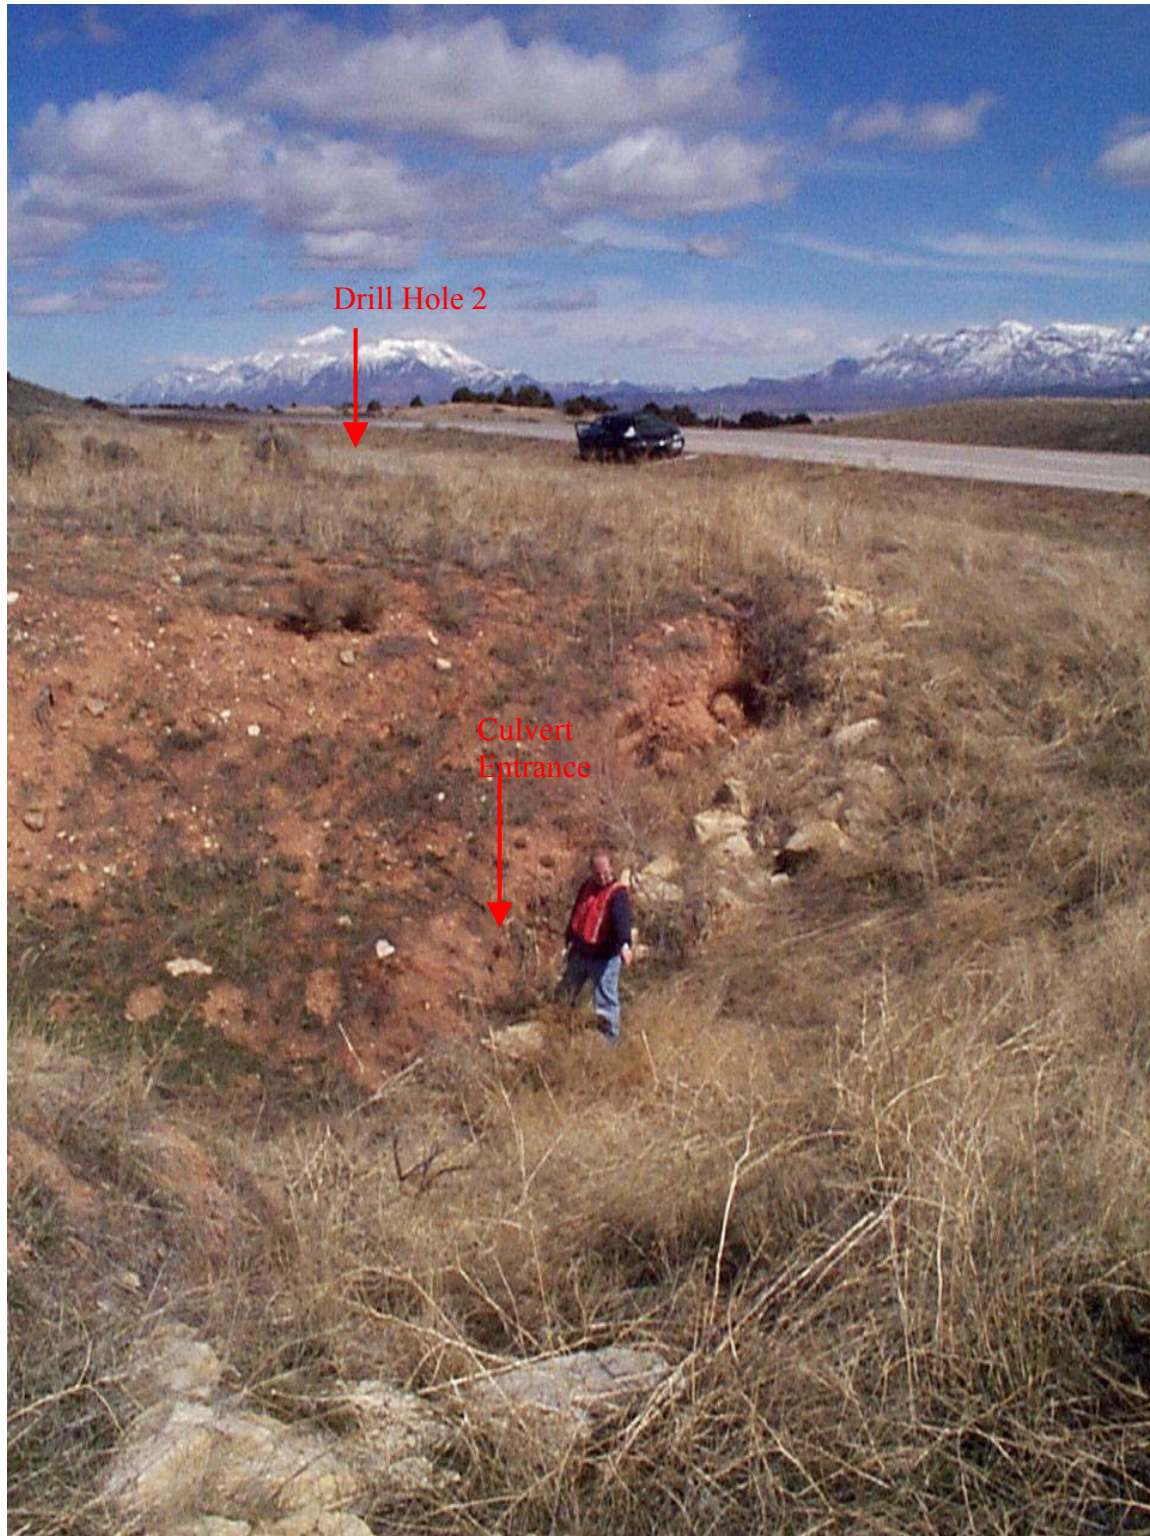
Figure 40: Plant growth at drainage near Drill Hole 2, Juab County, UT.

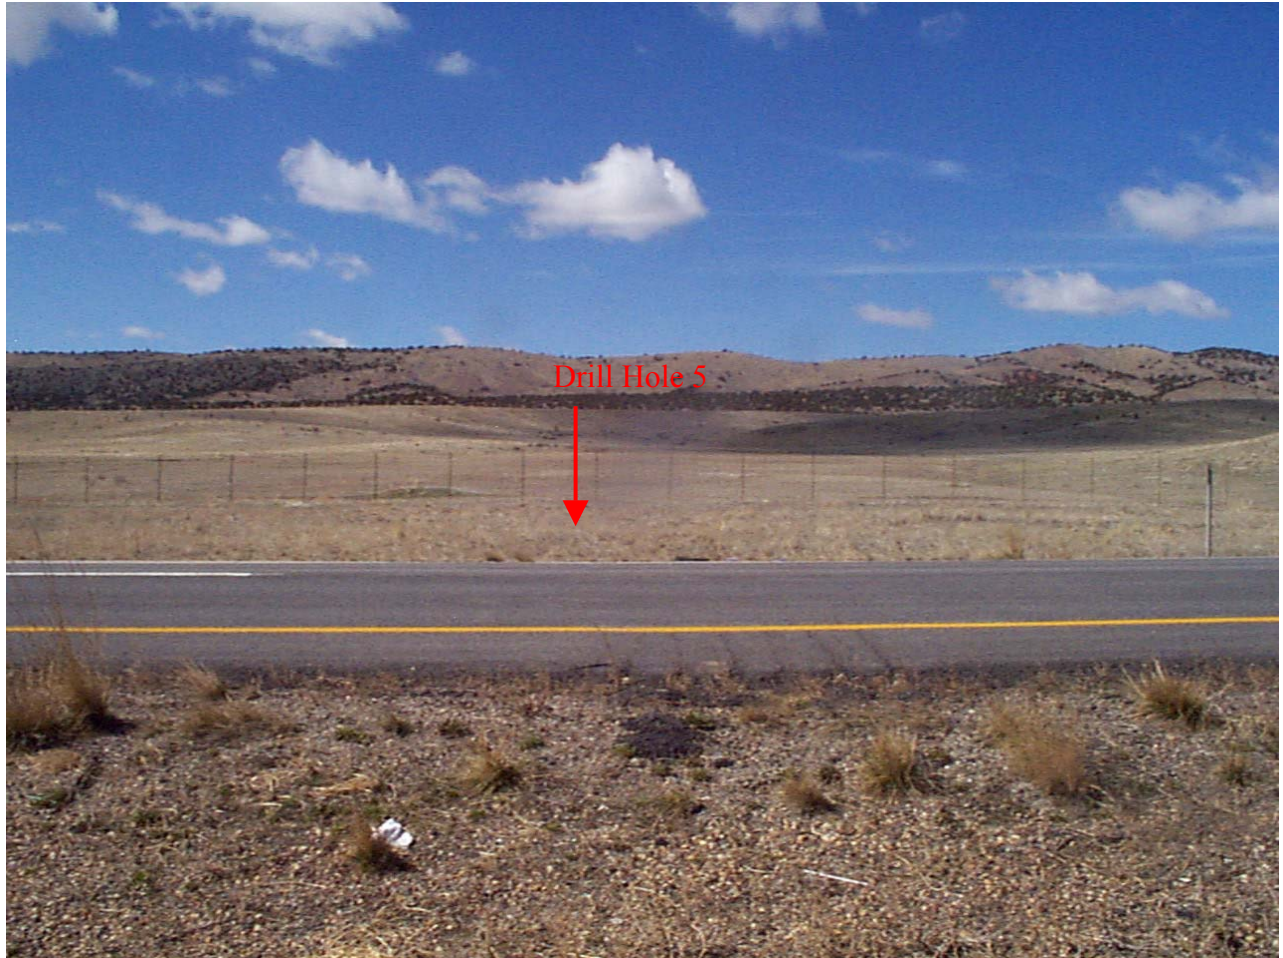
Figure 41: Looking west at the area around Drill Hole 5 near the southbound lanes of I-15. Drill Hole 5 was drilled in the center of the photo through the stream alluvial deposits creating the flat section between the alluvial fans.

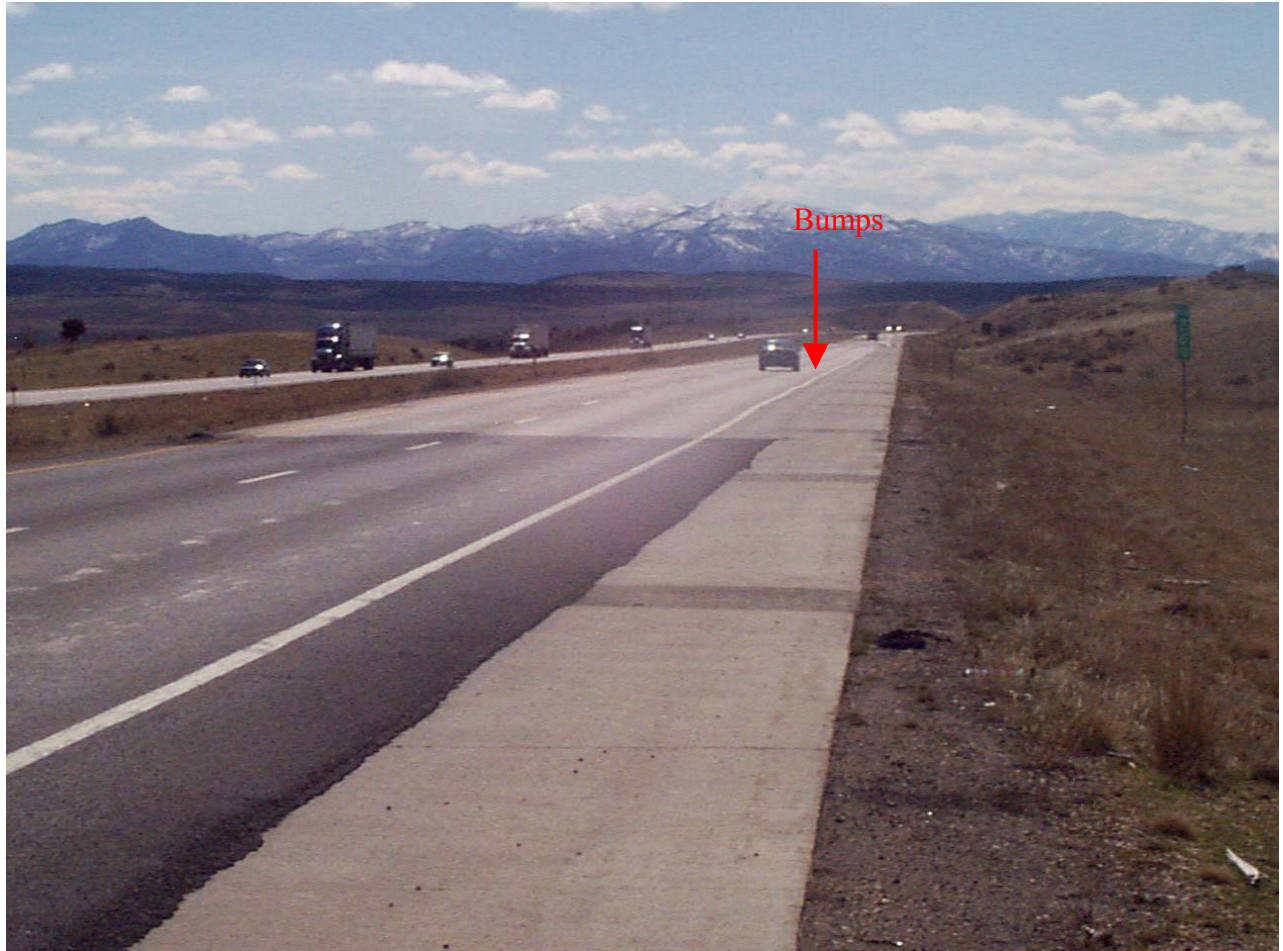
Figure 44: Looking south from Drill Hole 5 along the southbound lanes of I-15. Several bumps can be seen in the middle of the photo.

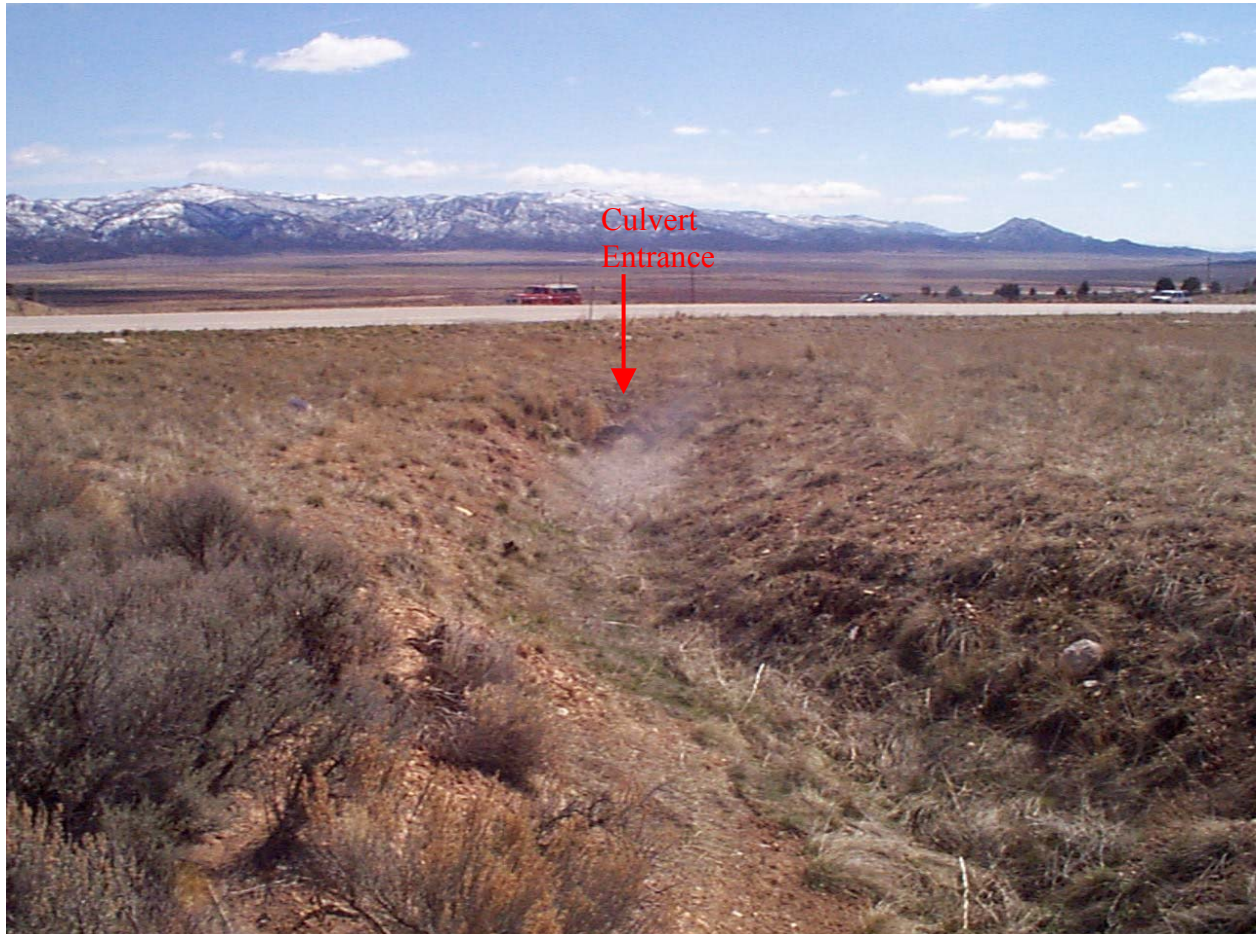
Figure 45: One of the two culverts that passes under I-15 from west to east near Drill Hole 5. The drainage is partially blocked by plant growth.

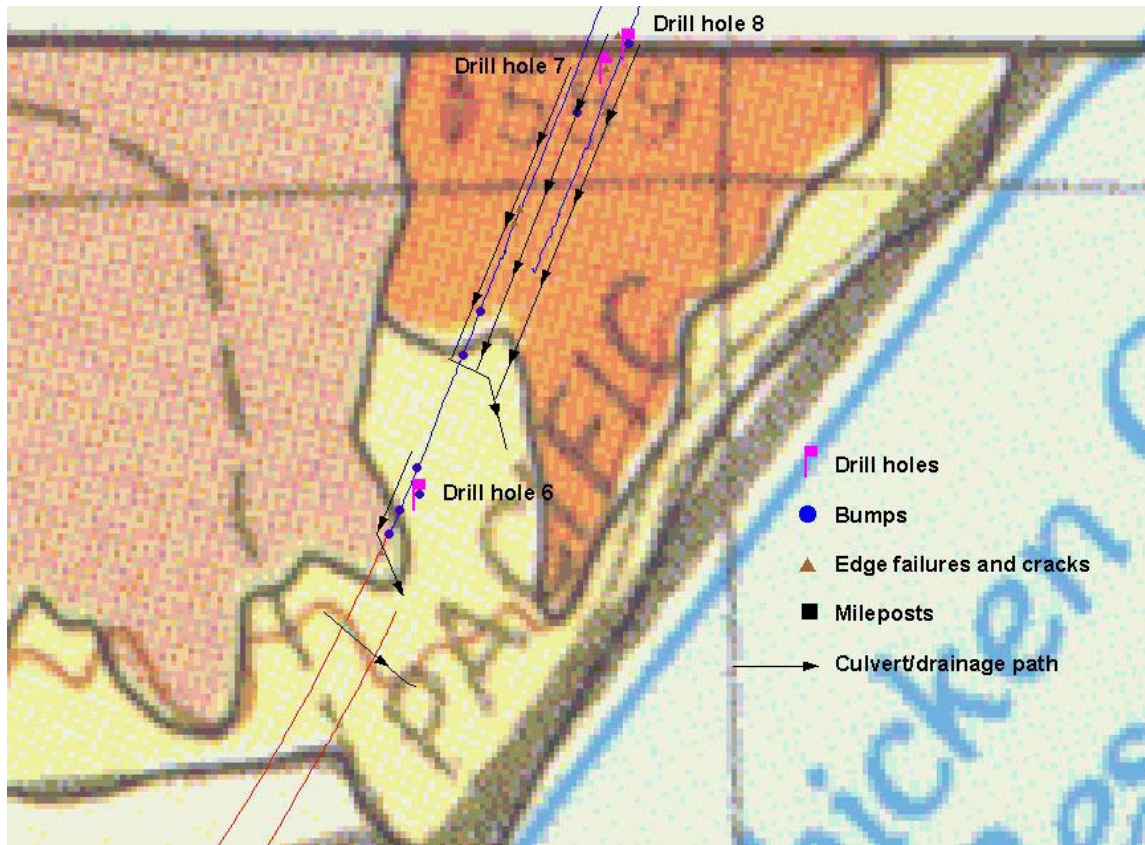
Figure 55: Drill Holes 6, 7, and 8 and the distress features nearby, I-15, Juab County, UT. Cuts are in blue and fills are in red.

There are 13 distress features found on the map of the area around Drill Holes 6, 7 and 8 (see Fig. 55). Seven of the distress features are edge failures and six are bumps. Seven edge failures and five bumps are found within 100 feet of a culvert/drainage path. One bump is within 100 feet of both a culvert/drainage path and a cut/fill transition. All of the distress features appear to be related to expansive soils which swell and shrink with changes in the moisture content. The drainage ditches along the highway are allowing water to pond. This water can then permeate into the soil and lead to heaving of the highway. In addition, when the water reaches the shales, the potential for weathering is increased and even greater problems with expansion can occur. This phenomenon was clearly evident at locations where hand samples were cut. The shale had weathered and softened into expansive clay in zones where water had

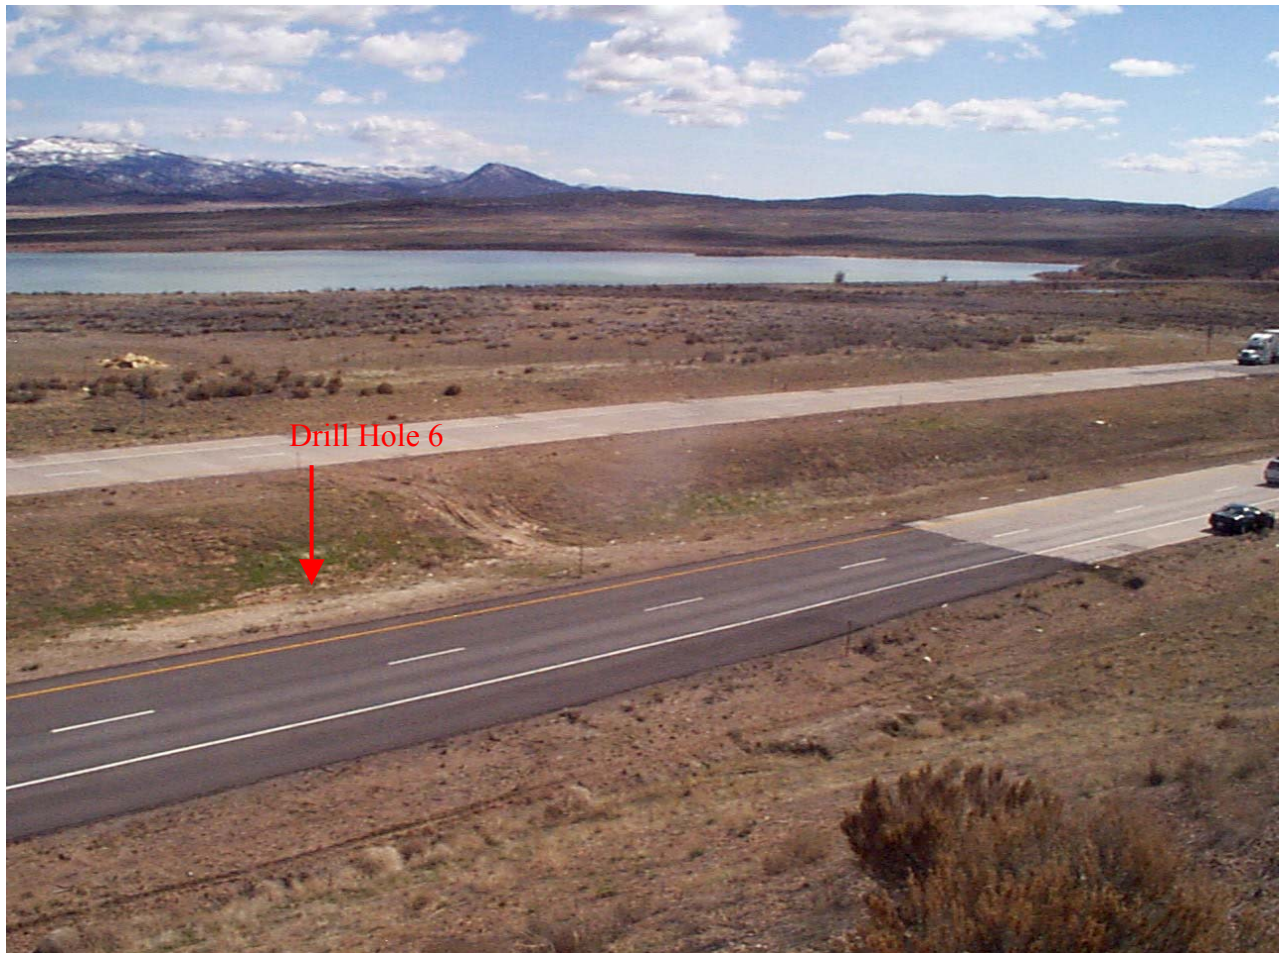
Figures 60 through 64 are pictures of the area and distress features around Drill Hole 6. They show where Drill Hole 6 is located, a surface overlay near Drill Hole 6, bumps, pavement offsets, and a plant-filled drainage along the west cut bank of I-15. Figures 65 through 69 are pictures of the area and distress features around Drill Holes 7 and 8. The pictures show where Drill Holes 7 and 8 are located near the northbound lanes of I-15, longitudinal cracks making up part of the edge failures within this study, a large bump, and a rock-filled drainage ditch along the east cut bank that has ponded water in it. A similar situation was observed for the drainage ditch running down the median in this section of the freeway.

Figure 60: Elevated view of the area around Drill Hole 6, looking southeast. I-15 goes through the middle of the picture. Drill Hole 6 was drilled in the middle of the picture through the east fill slope of the southbound lane.

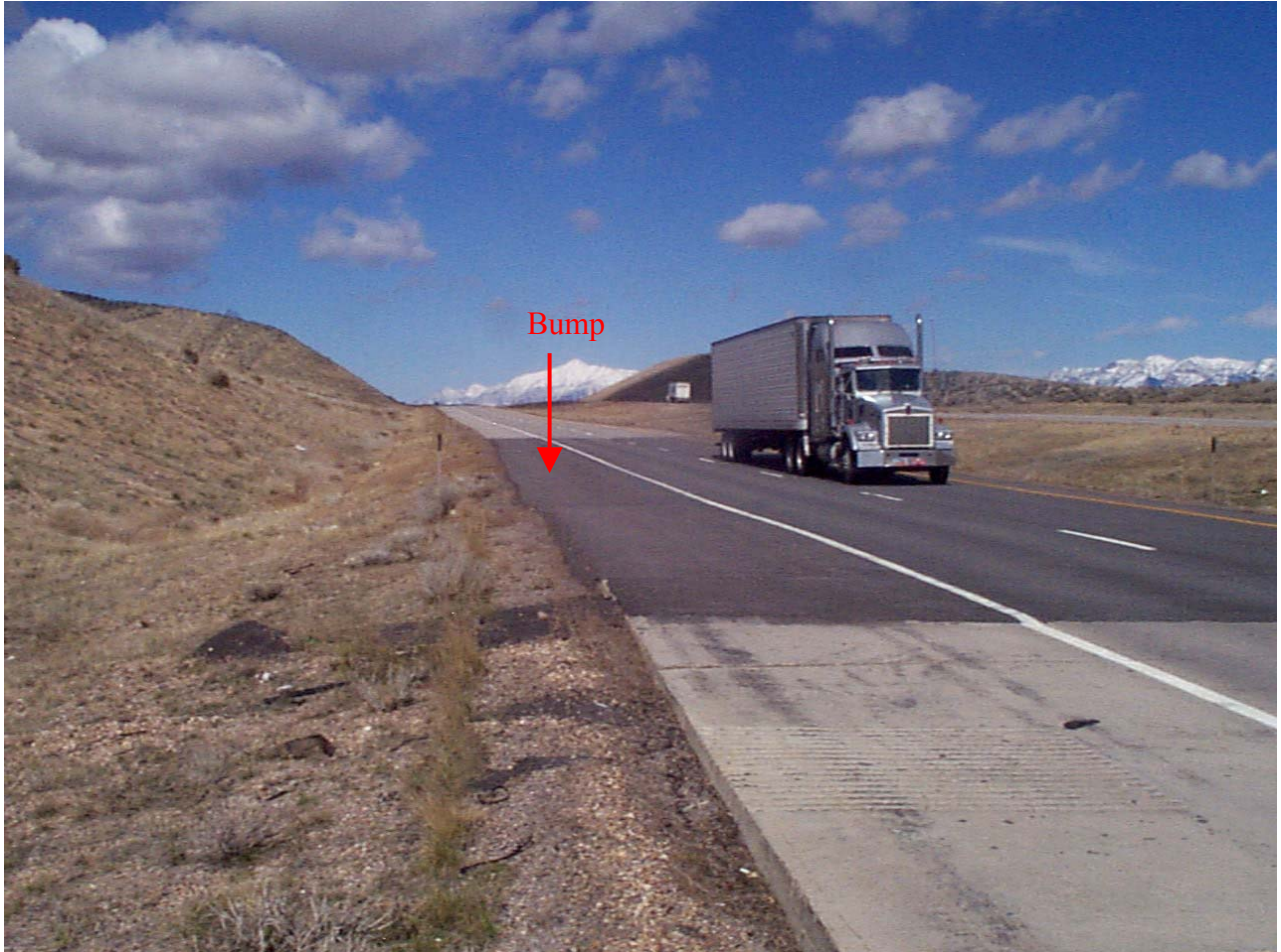
Figure 61: Bump and surface overlay along the southbound lane of I-15. Picture was taken looking north and Drill Hole 6 is to the east (not shown).

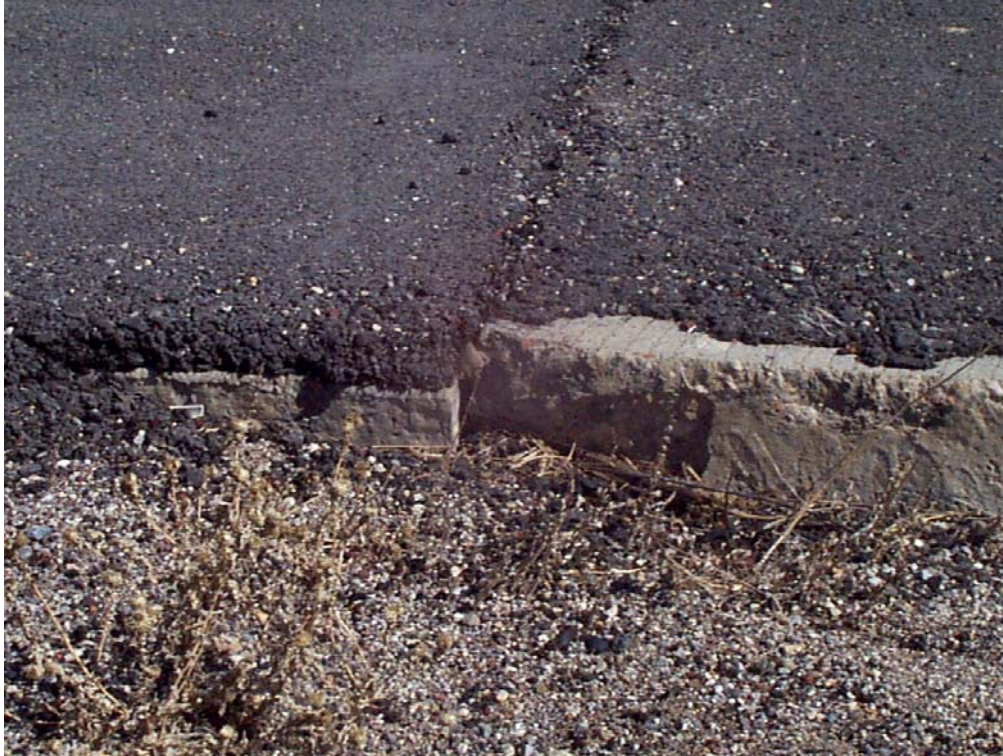
Figure 62: Pavement offset from a bump along I-15 southbound, near Drill Hole 6, Juab County, UT.

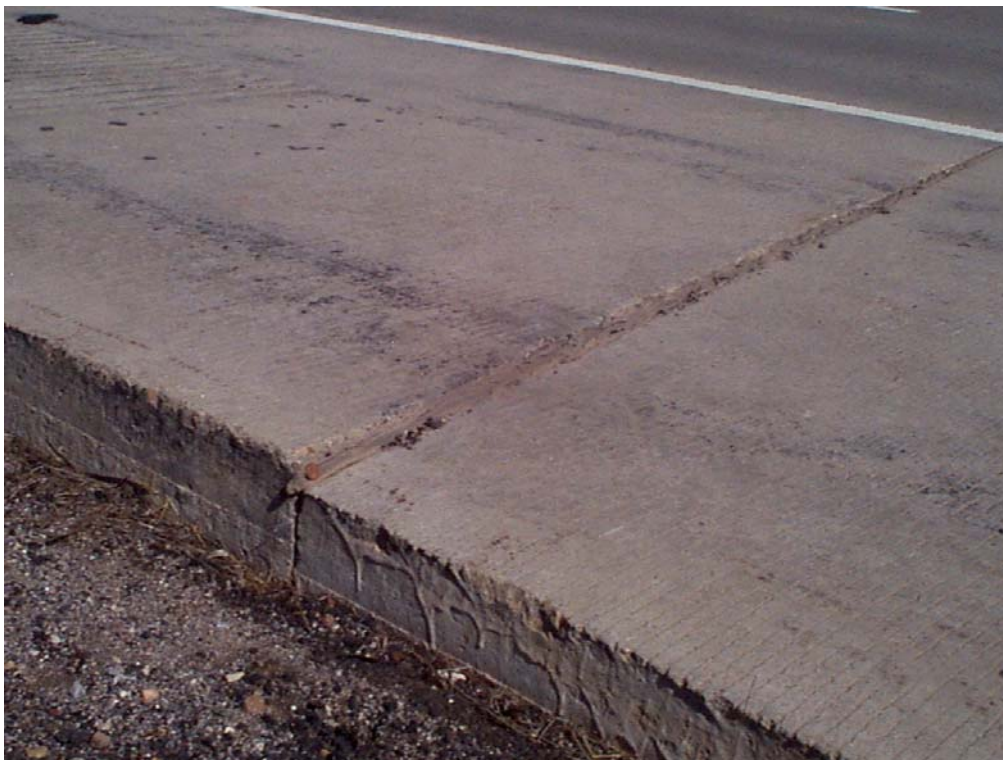
Figure 63: A second pavement offset along I-15 southbound, near Drill Hole 6, Juab County, UT.
